# T-MASH 18

The first Tertu's steel backed timber barrier crash-tested according to U.S standard MASH

# T-MASH 18 steel backed timber guardrail

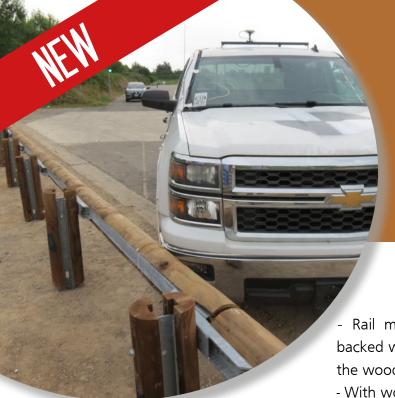
- Rail made of a round log ø 18 cm backed with a steel U channel inserted in the wooden rail
- With wooden spacer & post-cladding
- C100 steel posts in 1.50 m: 2 m spacing
